**FINAL INVESTIGATIVE REPORT  
COMMUNITY & TECHNICAL COLLEGE  
PARKING GARAGE EVALUATION**

**2012052 CTCGE**

**Fairbanks, Alaska**

July 2013

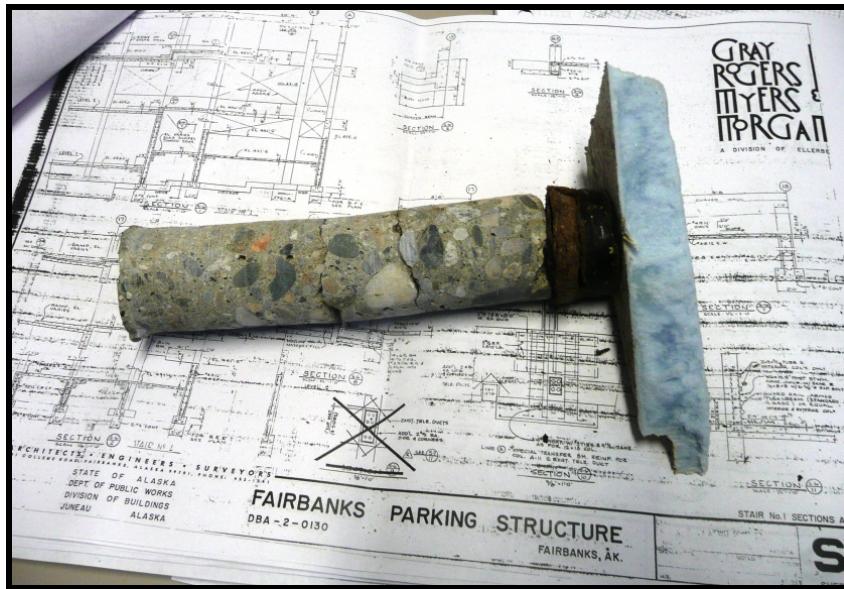
**Figure 1: Roof Core Sample**

Beneath the 4-inch slab, it was revealed that a layer of 1 inch blue board insulation and a 1-inch to 1-1/2-inch layer of roofing material was sandwiched between the 4 inch topping slab and the 6-1/2-inch structural slab. The blue board insulation was completely saturated with water and frozen solid. The roofing material appeared to be highly compressible, and in conjunction with the insulation would appear to be a poor sub base for the topping slab considering the traffic load. The 6-1/2-inch structural slab concrete appeared to be in good

condition. The as-built drawings indicated that the typical construction was intended to be the 4-inch topping slab, 1-inch rigid insulation, built up roof and 3 inches of rigid insulation on top of the structural slab. It appears that the bottom 3 inches of rigid was not used for this project. A note on the as-built drawings also states, "Roof Topping to Remain When Future Floor & Roof Added." This would indicate that the original intent was to have four (4) levels of parking and roof to cover the building.

After reviewing the destructive testing results and field observations of the water filtration issue, USKH recommends that the topping slab and roofing material be removed down to the structural roof slab. The cracking in the topping slab due to the compressible sub base of insulation and roofing material has led to saturation of the insulation and roofing material. The water is trapped between the concrete slabs and expands when frozen to further damage the topping slab. It is worth noting that when the water does find its way out, it will not be into a drain system, but rather through the edges of the slab, slab penetrations or joints in the slab.

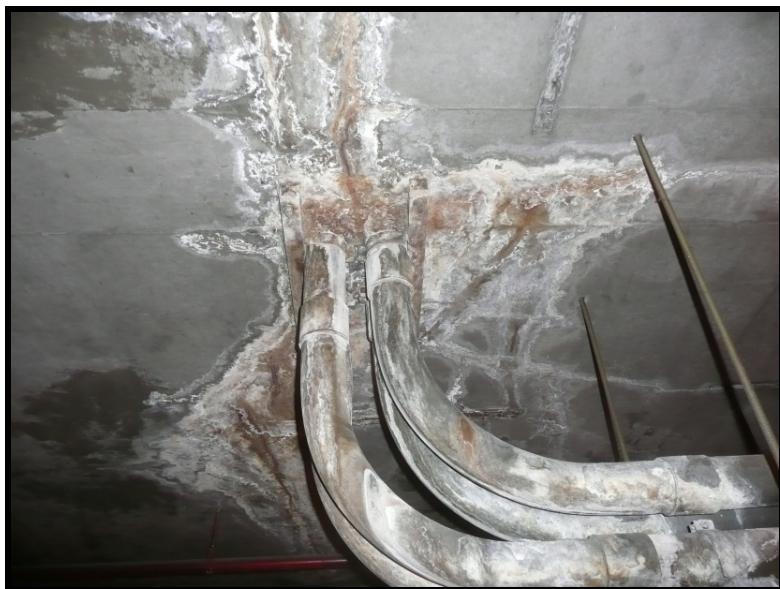
**Figure 2: Water Observed at Penetration in Roof Slab**

It appears that work has been performed to attempt to eliminate or dry the saturated layers between the slabs, by core drilling a hole from below to allow the space to drain. It was observed that during the concrete cutting, the water from the concrete cutter made its way to a core drilled hole in the structural slab approximately 60 feet away. There was no hole in the topping slab, so the water traveled beneath the topping slab to find this drain. The gutter overflowed very quickly.

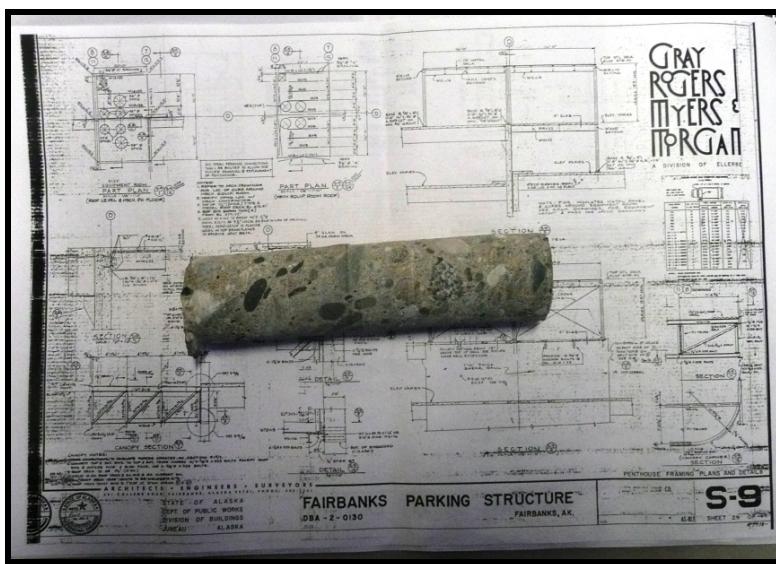
**Figure 4: Floor Core Sample**

A core sample of the structural floor slab at the second level was taken and the concrete appeared to be in good condition at this location as well.

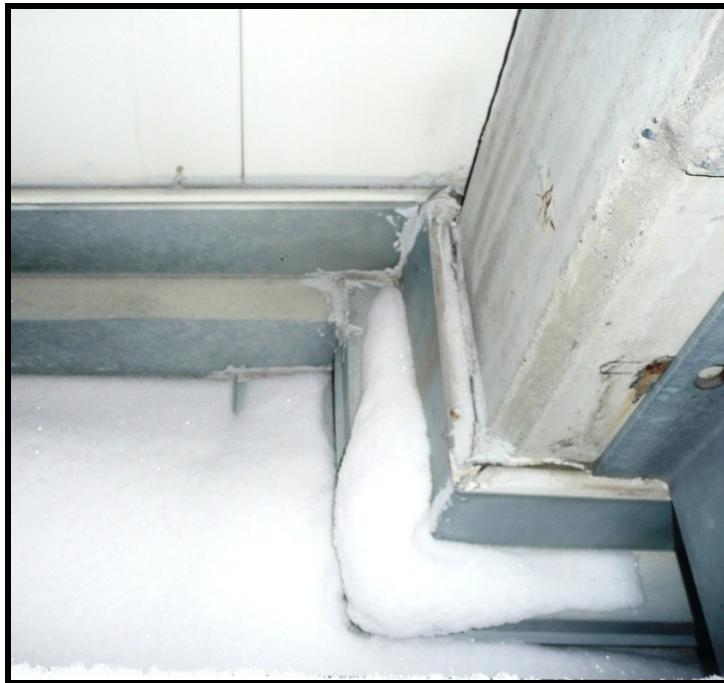
**Figure 5: Flashing at Exterior Wall Panel/Concrete Column**

USKH has reviewed the installation of the flashing at the upper level and it is our opinion that the flashing was a temporary solution to alleviate water infiltration until the roof was constructed. In some places we found that the flashing was interrupted by the wind girts for the wall panels.

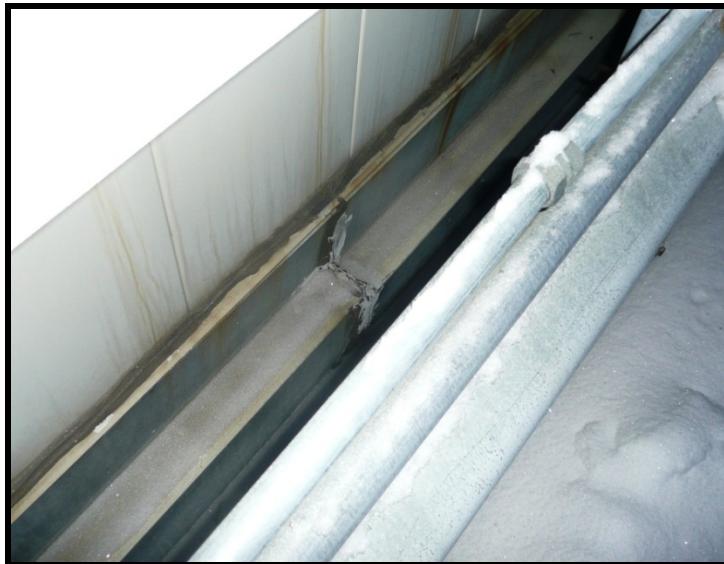
**Figure 7: Caulking at Flashing Joints**

The flashing appears to be a maintenance issue since the joints between the individual pieces of flashing appears to have been caulked multiple times.

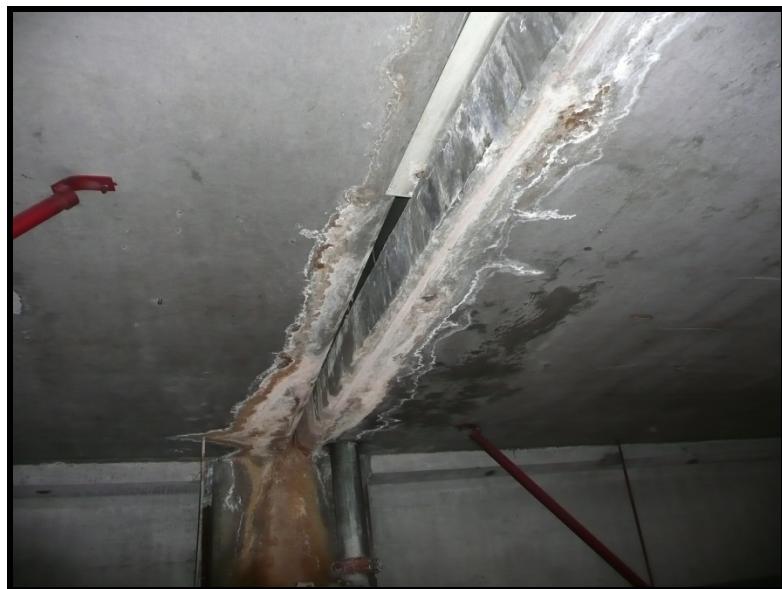
**Figure 8: Water Marks Observed Below the Roof Level**

At the lower levels there are obvious signs of water infiltration from the flashed area above, which indicates that the flashing is not working as intended. The flashing connection to the panels, the joints between the flashing and damaged areas of the flashing appear to be allowing water inside the parking structure.

The water damage observed in the above picture may be from a combination of the damaged flashing and infiltration from between the topping and structural slabs.

Based upon the investigation of topping slab and flashing conditions; USKH recommends that the topping slab, insulation board and roofing materials be removed and the slab sealed in order to improve the water infiltration issues at the lower levels. The existing topping slab, insulation and roofing material does not have the structural integrity and is not acceptable to receive a waterproof coating.

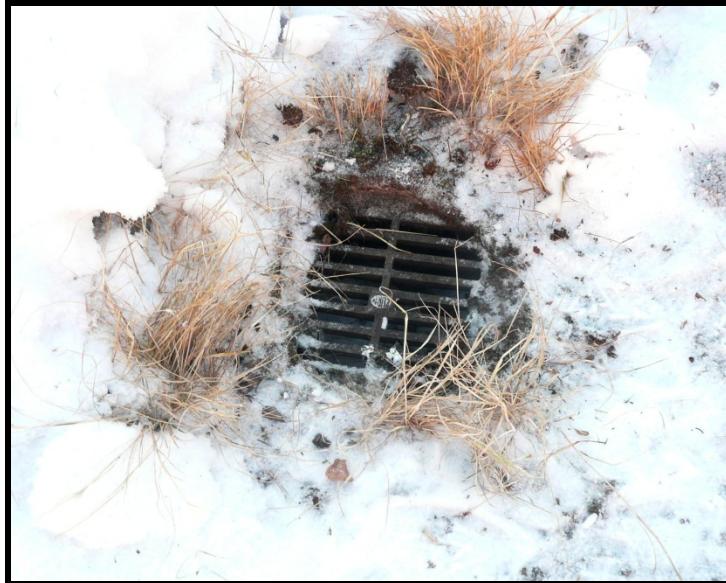
**Figure 9: Shrubs and Moss at Upper Level Drain**

USKH inspected the upper level drains as well as interior level drains of the parking garage. The drains appear to be in fair condition, though there are some fittings that show substantial surface corrosion and several drains on the upper level are surrounded by soil, moss, and shrub growth.

The upper level drains appear to be set into the upper floor slab only and the structural slab below is core-drilled to provide passage for the drain's conductor piping. Subsequent slabs down through the structure have been sleeved to provide passage down to the lower levels. The drains in each lower level are similarly set into the slab. There are several locations where the structural slab on the upper level appears to have been drilled through to provide an outlet for moisture that has accumulated between the two slabs. These holes and associated piping and/or gutters may be removed and the holes plugged once the sealing project is underway.

When the upper-most floor slab, insulation and roofing material are removed to allow for the sealing of the structural slab the existing drains will need to be removed. The drain conductors will need to be shortened and it is recommended to install new flush-mounted drains in the structural slab. The existing drains may possibly be reused although it would be labor-intensive to carefully remove the drains from the existing slab and clean them up without damaging the drain. If new drains are provided, they should be provided with a stout strainer or grit basket below the surface grate that can be easily cleanout out. This will prevent grit, dirt and debris from entering the drainage piping and clogging the system. Putting the cleaning of these strainers into a regular maintenance schedule will also provide the opportunity to remove any sediment that may build up around the edges of the drains that may otherwise block water from entering the drain and provide a substrate for mosses and shrubs to grow around the drain.

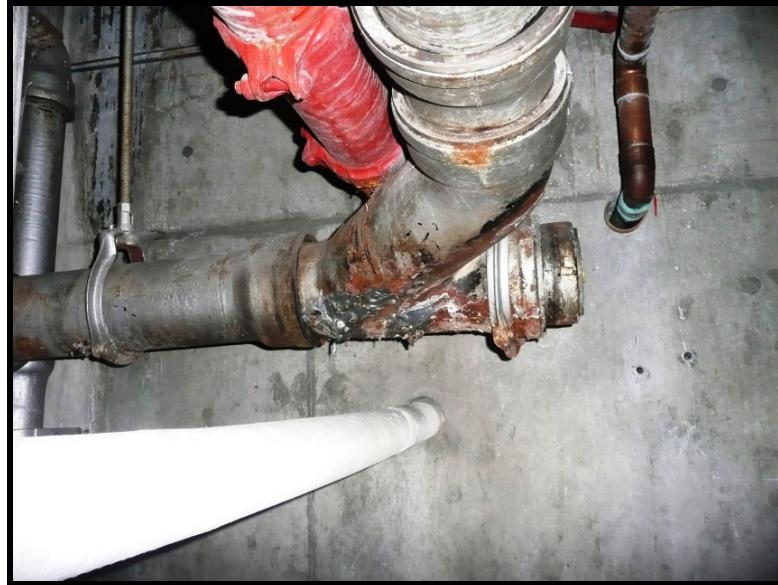
**Figure 10: Flexible Caulking Fix on Wye Fitting**

There is a sanitary-wye fitting at the lowest level on the south side of the garage at the bottom of the drain conductor that appears to have been cracked sometime in the past and was "fixed" with what appears to be a flexible caulking material. This fitting should be replaced with a new fitting that is not damaged.

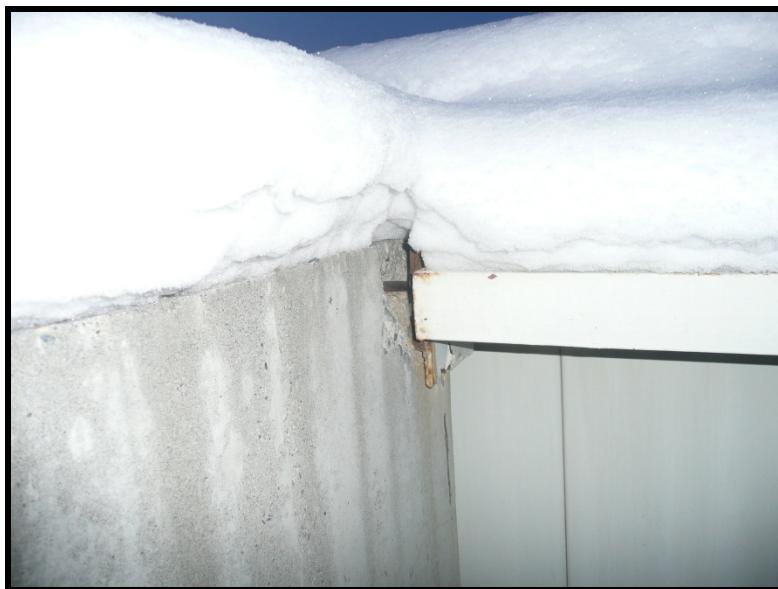
**Figure 11: Wind Girt Connection Failure 1**

The exterior wall panels are supported by steel channel girts that span between the exterior concrete columns and walls. The wind girts are spaced at approximately 5-foot centers vertically and are connected to the panels with self-tapping screws, and to the concrete structure with steel embeds. Field observation found that the connection between the wind girts and the structure did not account for expansion and contraction due to temperature change. The steel channel girts were failing at the connections at some locations, and exhibited signs of corrosion in many places. Wind girts appeared to be bowing in other locations as well. USKH recommends that if wall panels are removed, that the wind girts associated with the panels shall be removed as well. At locations that wind girts are removed, guardrails would need to be installed for safety purposes. Further study is recommended to address aesthetic issues for creating the openings for ventilation and to address structural integrity of the girt framing system.

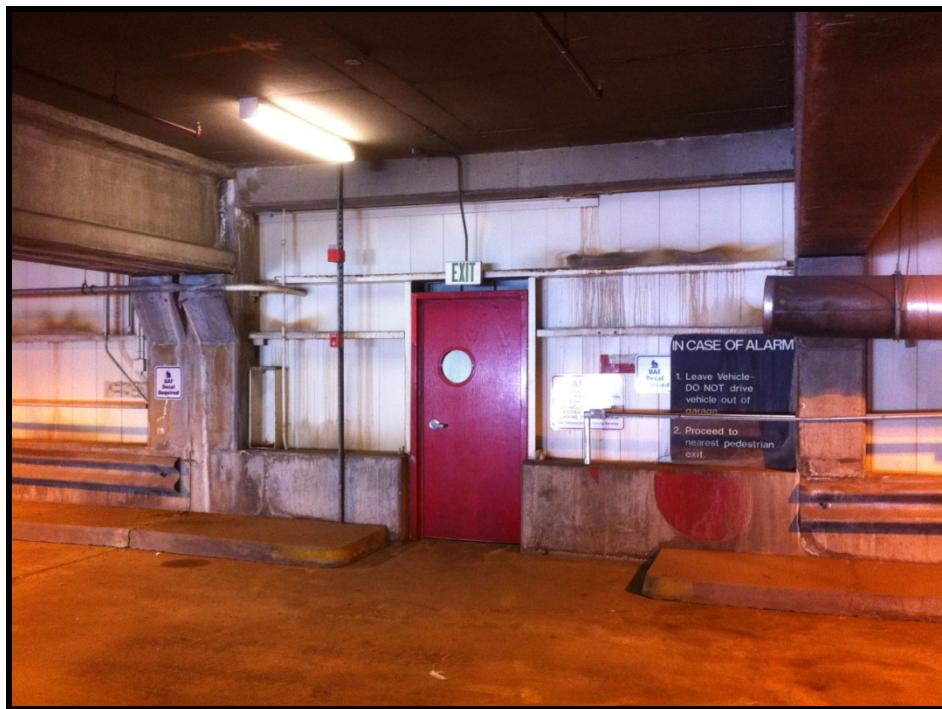
Figure 13: Typical Existing Interior Level Finish Appearance

- Extend the life of corroded and degraded materials.
- Provide cleaning of and restoration at water damaged areas.
- Create brighter and more reflective interior finishes, particularly at the ceiling and upper walls to more effectively reflect and distribute light.
- Create an overall more aesthetic and brighter interior appearance.
- Revise the highly dated 1970s colors used at the few areas that are painted.
- Provide interior lighting that is more energy efficient and of a more natural, aesthetic color.
