# A White Paper on Energy Use in Alaska's Public Facilities

Published 11/7/2012 | Version 1

**Alaska**  
**Housing**  
FINANCE CORPORATION

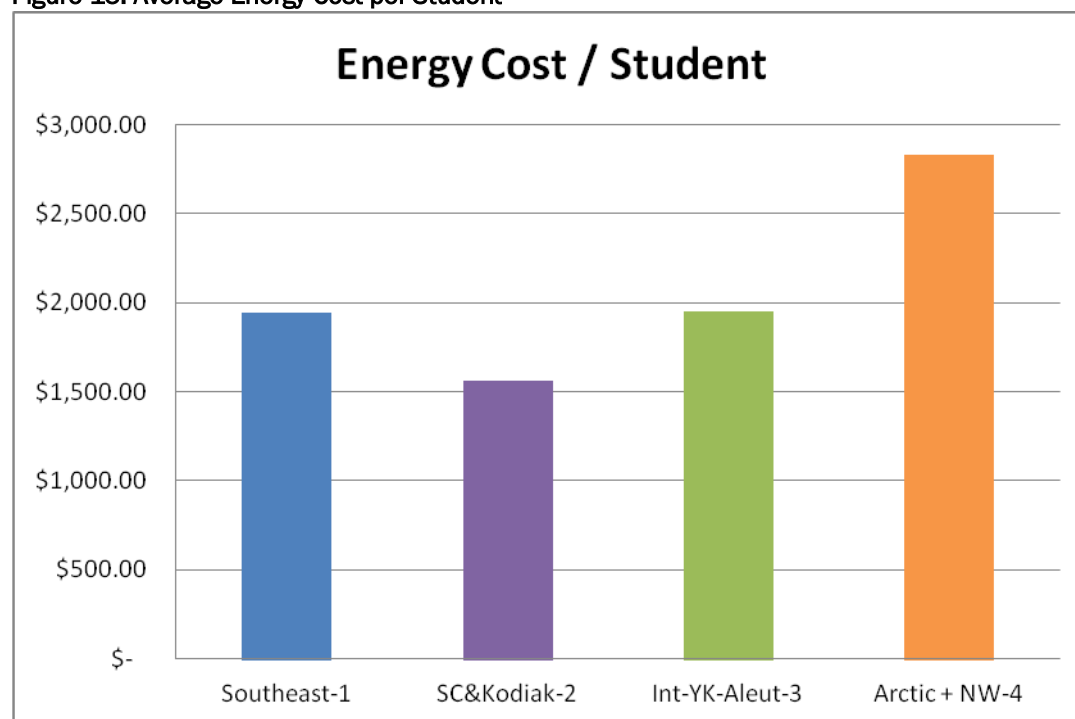
Figure 15: Average Energy Cost per Student

There are many potential causes of this variation; CCHRC looked at climate, energy prices, building age, building size, and school enrollment to determine the general effect of these factors on the average energy cost per student.

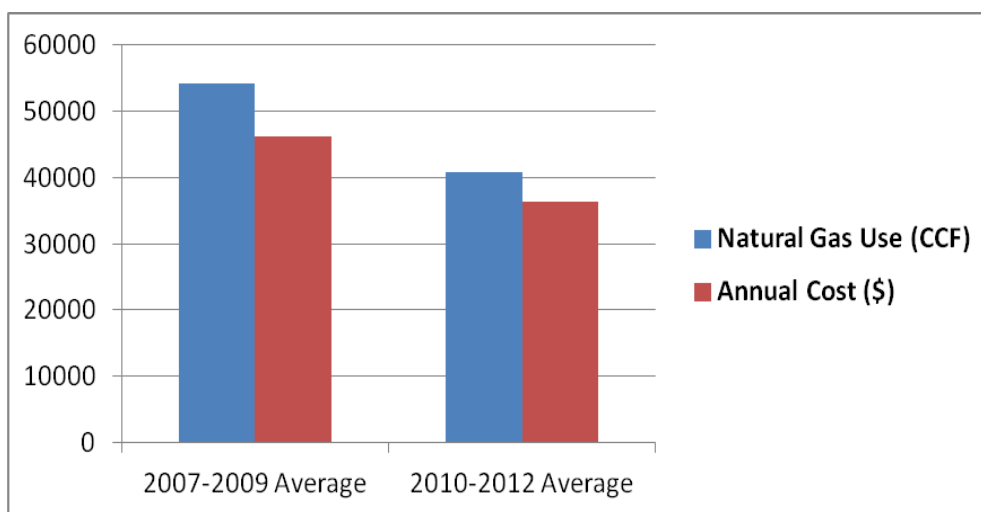
**Impact** Klatt Elementary was provided with modern high-efficiency condensing gas boilers as a flagship project for ASD replacing 26 year old gas fired Weil McLain sectional boilers. From the utility data provided, the installation of these boilers and the degree of control provided by the DDC system has reduced the annual natural gas use of this building by 24.6 percent, based on the average annual consumption over the three-year periods of 2007-2009 and 2010-2012. Figure 1.0 shows the difference in natural gas used in Hundreds of Cubic Feet (CCF) and Annual Cost for Klatt Elementary’s natural gas usage over the three-year averages mentioned earlier. Cost savings over this period were shown to be \$9,945 annually, corresponding to a 21.5 percent reduction in actual cost paid for the natural gas used.

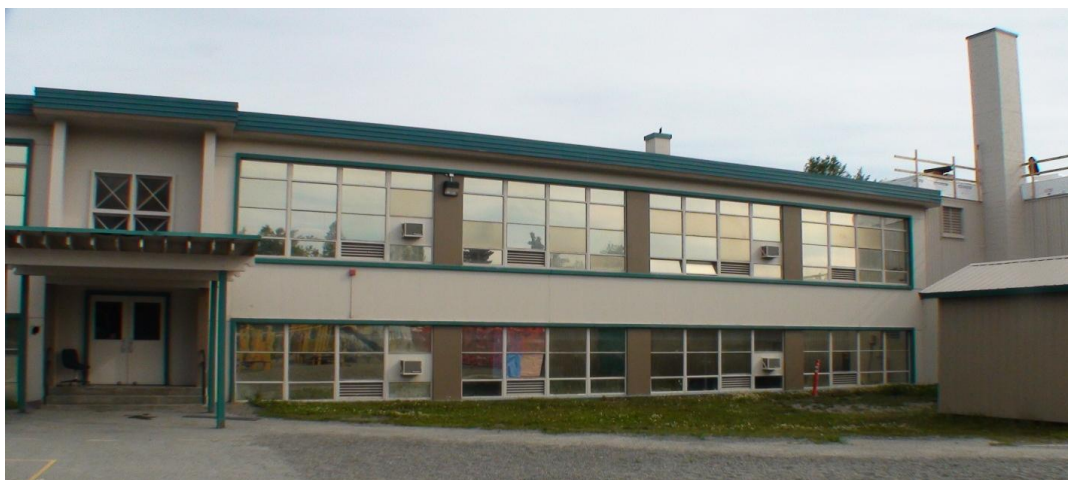
Figure 1: View of South Facing Windows with A-C Units

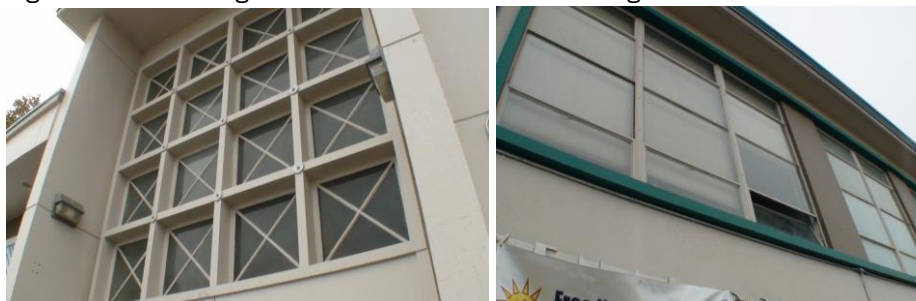
Figure 2: View of Single Pane Windows and North Facing Windows

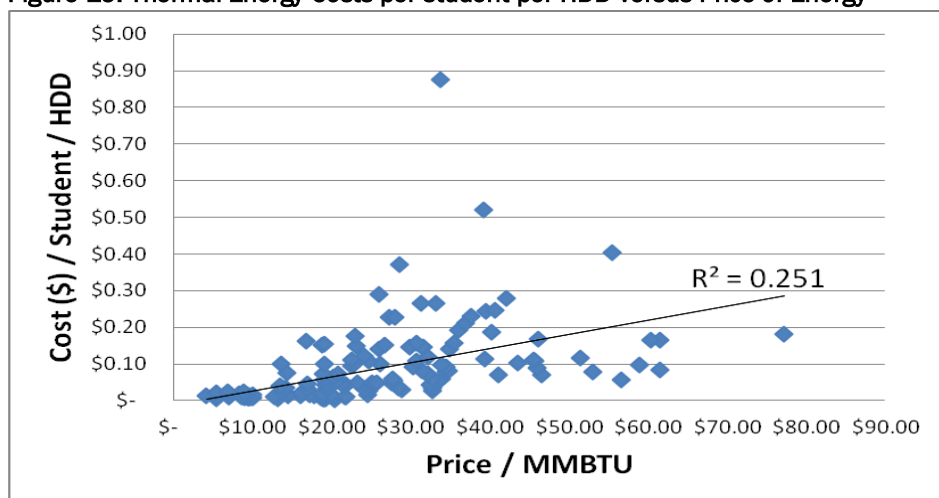
Figure 19: Thermal Energy Costs per student per HDD versus Price of Energy

Each data point represents one school. Upper bound outlier audit data points have been thoroughly reviewed and validated.

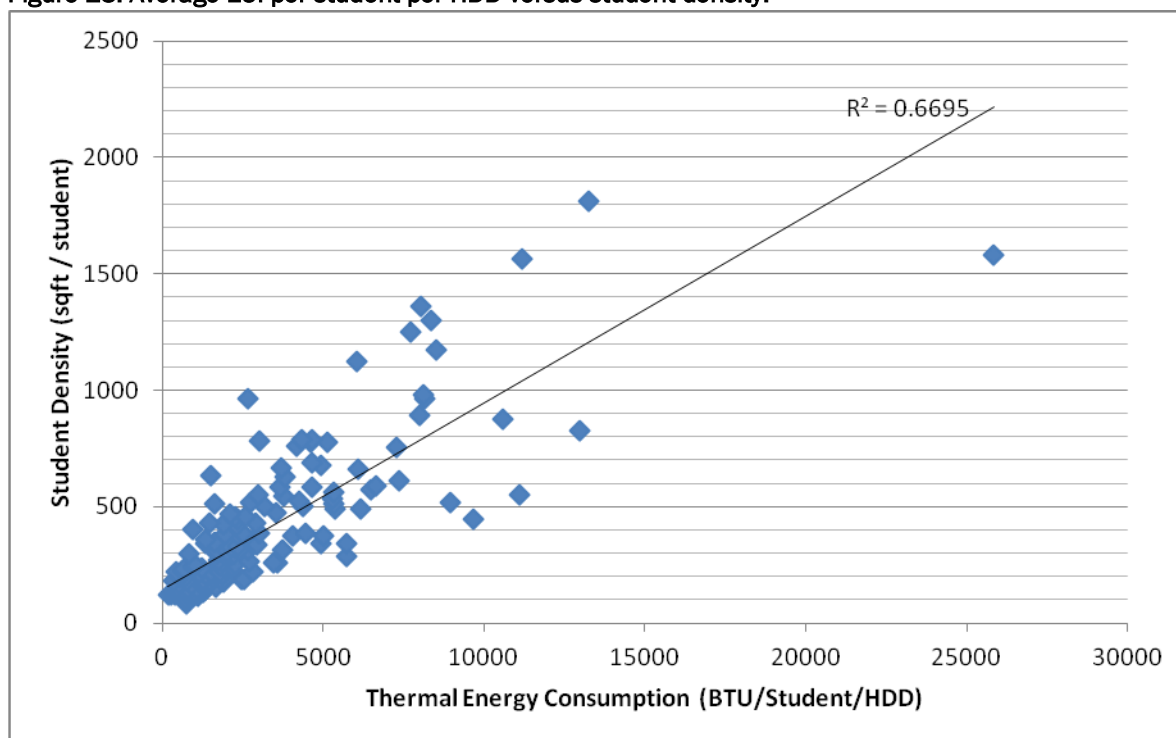
Figure 23: Average EUI per student per HDD versus student density.

Each data point represents one school. Upper bound outlier audit data points have been thoroughly reviewed and validated.

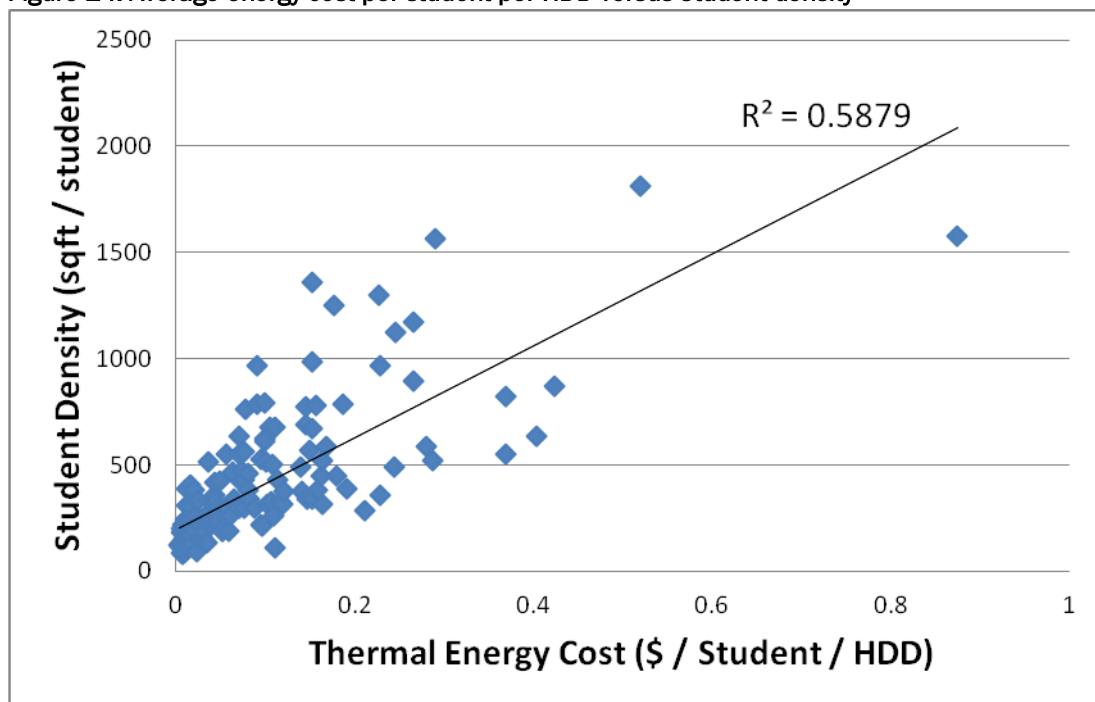
Figure 24: Average energy cost per student per HDD versus student density

Each data point represents one school. Upper bound outlier audit data points have been thoroughly reviewed and validated.

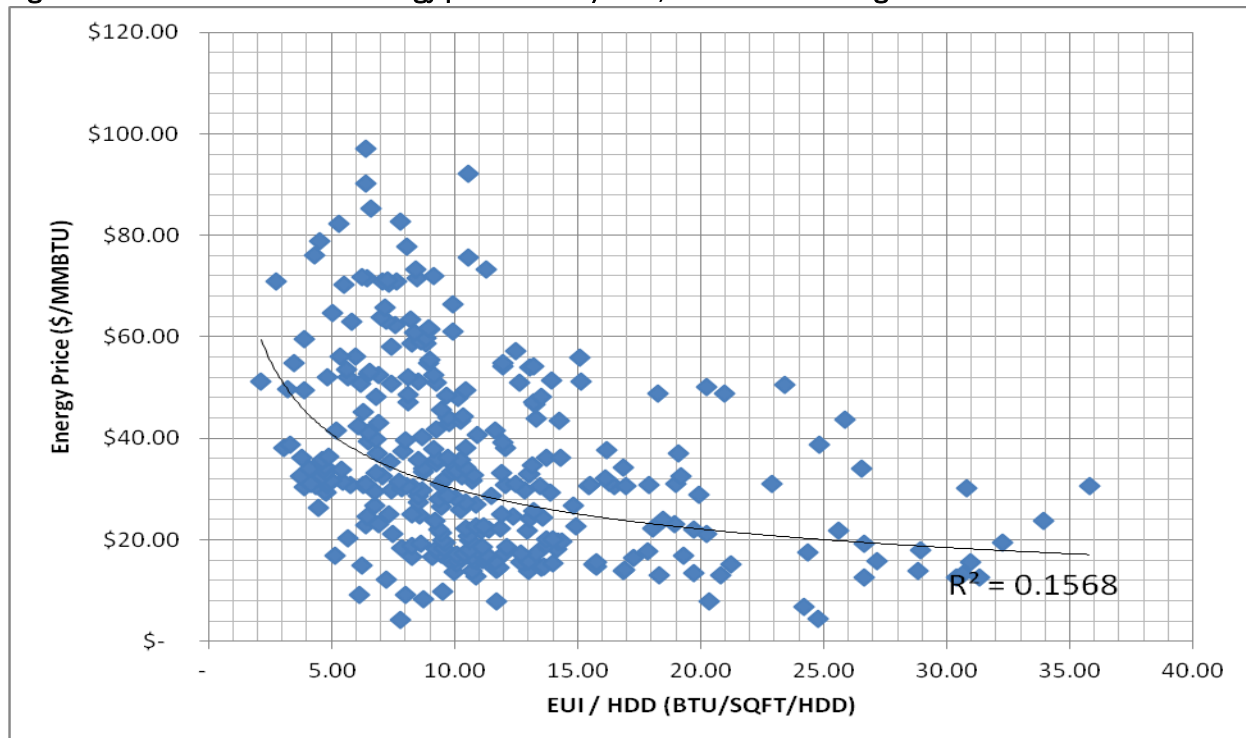
**Figure 29: Correlation between energy price and EUI/HDD, All Audited Buildings**

Each point represents one of the audited buildings. An  $R^2$  value of 1 indicates perfect correlation. In this case, the  $R^2$  value of 0.1568 indicates only a slight correlation. Outlier data was cleaned from this graph, and an exponential line of best fit was used as it appeared to model the data better than a linear line.
