Case Study: Yakutat Energy Efficiency Upgrade

2013 Village Energy Efficiency Program (VEEP)

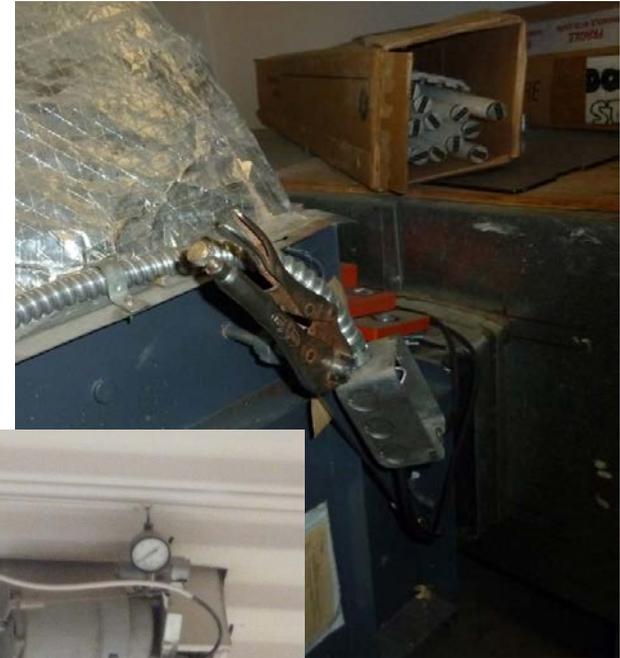
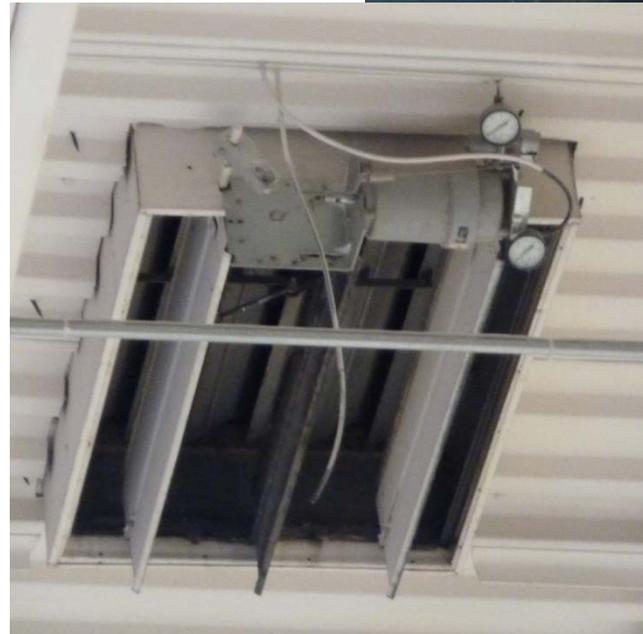
High School

- was pneumatic; now no controls, no pneumatics
- 1 AHU running backwards
- OSA dampers locked closed
- Relief dampers non-functional
- Local ball valves used to control zone temperatures
- On/off to control ventilation

- Demo remaining pneumatics
- Simple Electronic Controls on 6 AHU's
 - Prestige IAQ Controller
 - JADE Economizer Control
 - Honeywell T755 Analog Output Controller
- Combination of Wi-Fi & standard tstats
- New electronic actuators
- 3-way valves to 2-way
- VFD circulation pumps
- CO2 based demand controlled ventilation
- Re-pipe boiler room, remove boiler

- Correct improper hydronic piping
- Install BTU Monitor
- Fix hydronic leaks
- Replace defective coils & fintube
- Install freezstats and smoke detectors
- Replace missing locker room EF's, add Occupancy sensors
- Replace expansion tank
- Replace hot water generator
- Replace cabinet unit heater

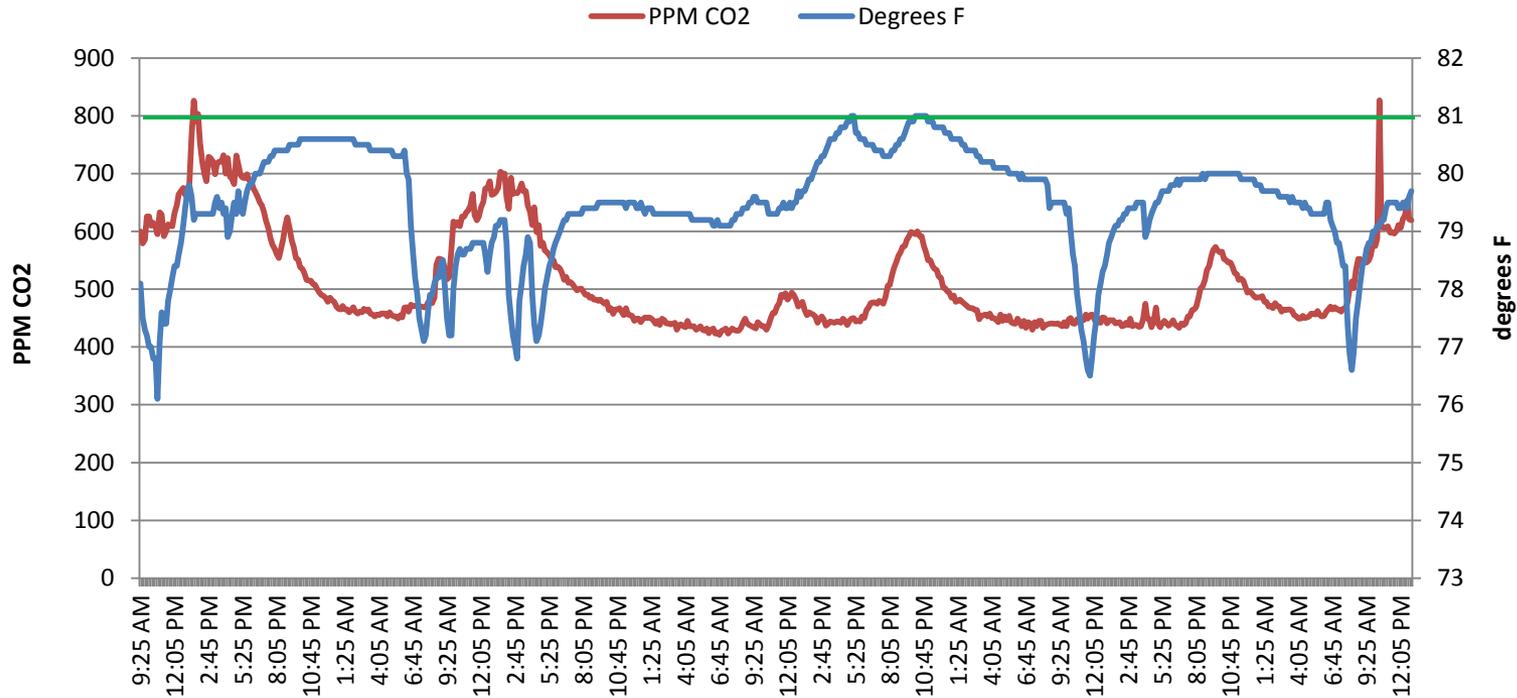
High School CO2 & Temperatures

Administrative Office; Thursday through Monday

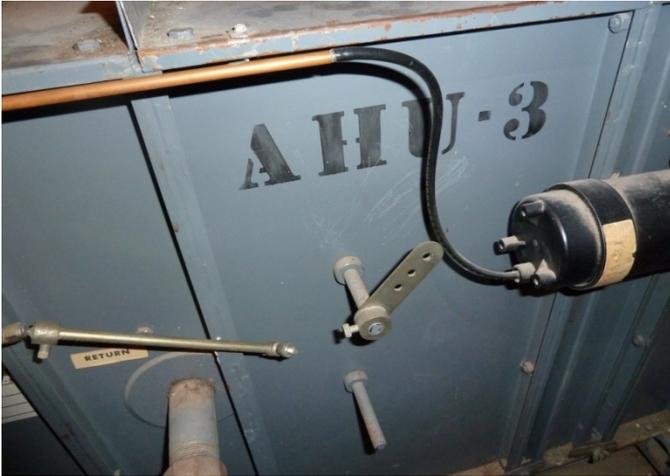
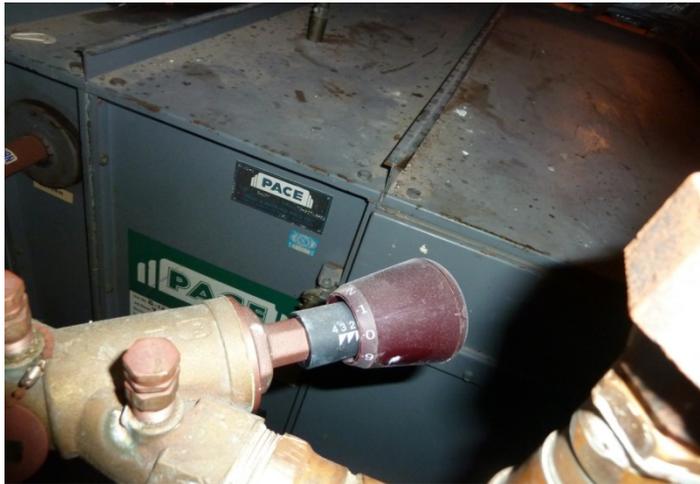
Elementary School

- Pneumatic, no controls, severe overheating
- Logged 8 hrs/day pneumatic compressor
- All AHU's running backwards (phase problem)
- Kitchen MAU disabled
- DHW running into cold water, back-feeding lav's & WC's

- Demo pneumatics
- Simple Electronic Controls on 3 AHU's (Natatorium AHU eliminated from program), same as High School
- 14 zone Wi-Fi tstats; add Wi-Fi coverage
- 14 new zone valves
- New electronic actuators
- 3-way valves to 2-way
- VFD circulation pumps
- CO2 based demand controlled ventilation

- Occupancy sensors on all EF's
- Install freezstats and smoke detectors
- Repair unit ventilator, replace fintube
- Replace oil fired HWH with HWG
- Install BTU meter
- Remove boiler & piping
- Repair hydronic leaks
- Replace pool circulation pump with premium efficiency
- Replace expansion tank

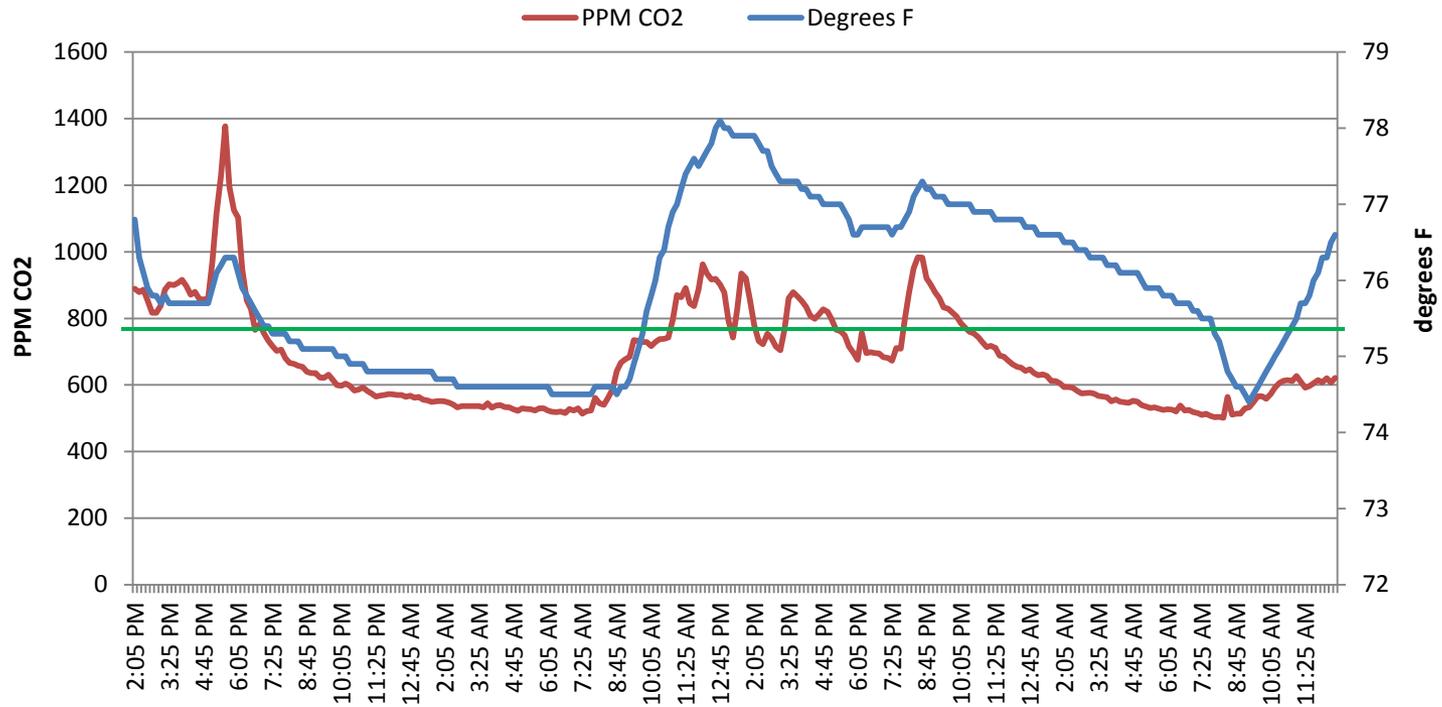
Elementary School CO2 & Temperatures

Tribal Conference Room (Elem. School Second floor); Wednesday through Friday

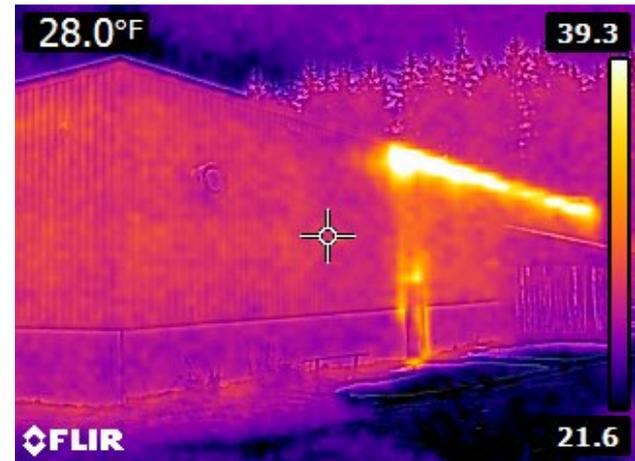
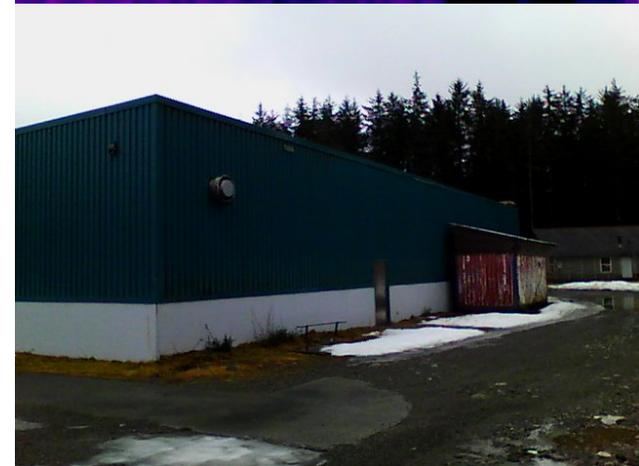
Natatorium

- 100% OSA de-humidification
- 2500 cfm EF removed
- Positive static pressure
- 89.5°F water temp, 88.5°F air temp, 65% RH
- corrosion

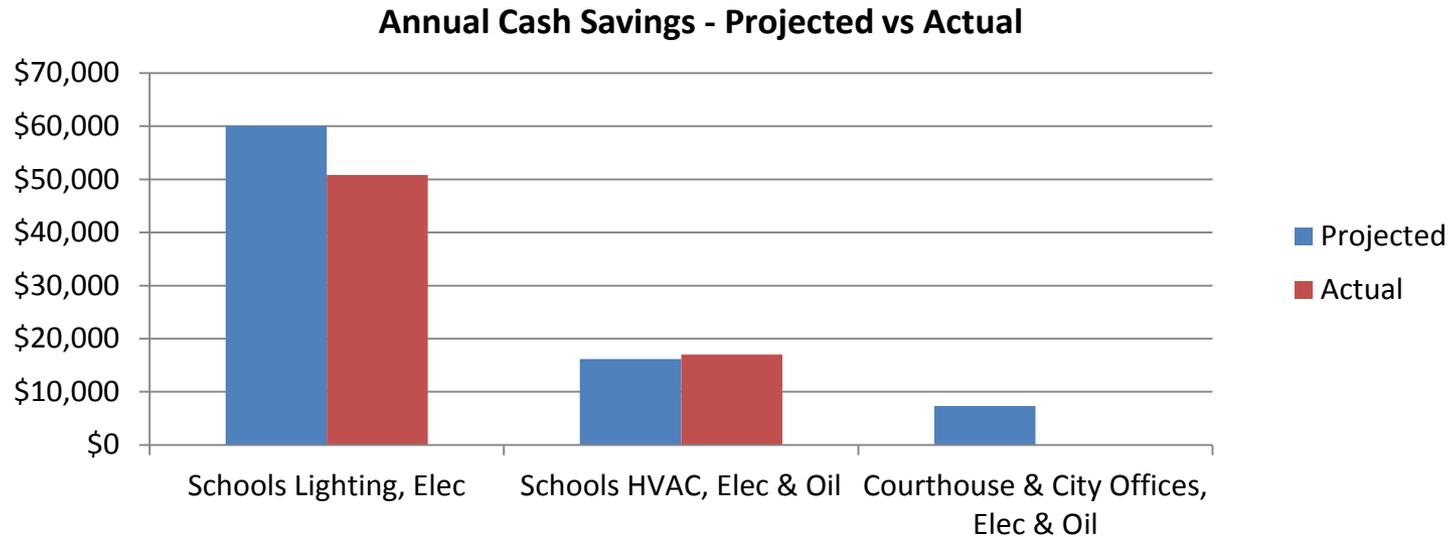
Actual Savings through July 2015

- No heating penalty for lighting upgrade
- No actuals yet for Courthouse & City Office
