# Building the Future NOW Sustainable Rehab, Simple Solutions

Andy Padian

PadianNYC Consulting

Energy Efficiency NOW: Elevating Performance in Commercial & Residential Buildings

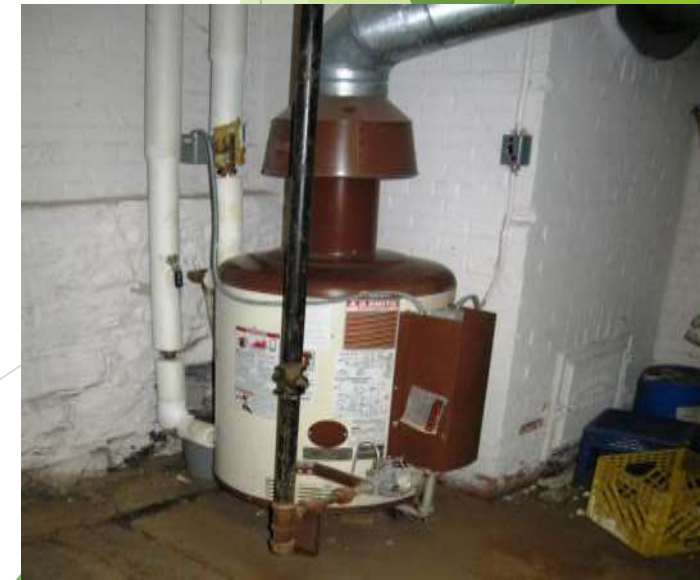
- 1873 Historic building
- Converted to senior housing
- Attic air sealing and insulation
- Heating and DHW replacement
- 20% savings
- **No preservation alarms!**

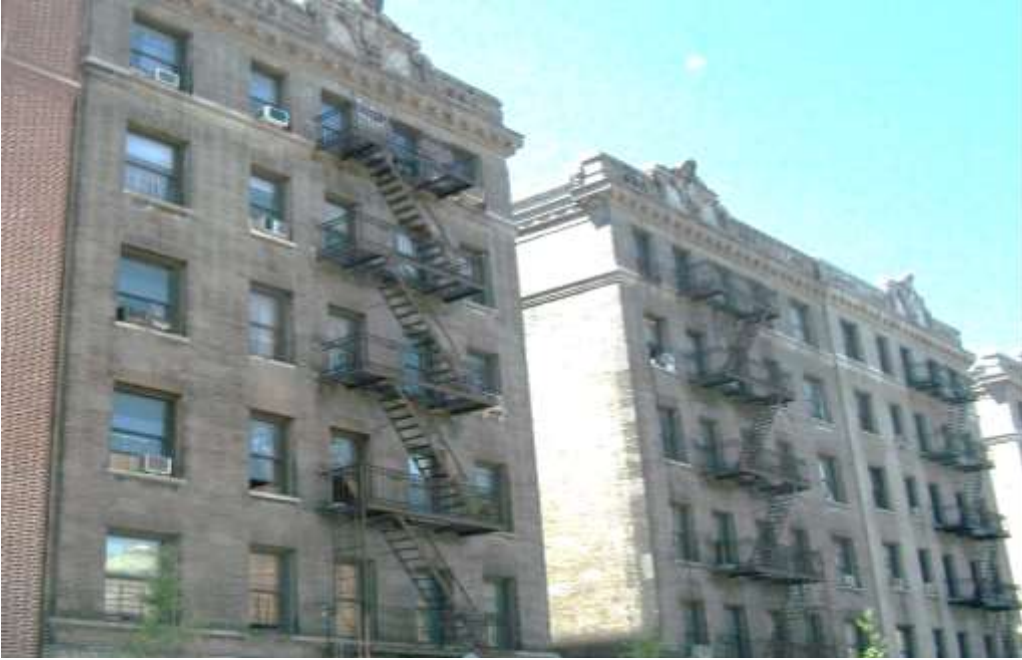
35 apts, 36,000 ft<sup>2</sup>

- Mod rehab + full weatherization package (\$4000/apt)
- Boiler, airsealing, windows, insulation, better controls
- Oil usage declined (weather adjusted) 63.7%.
- Annual oil usage from \$119,636 to \$43,448
- Savings of \$76,188 **(\$2177/apartment)** per year.

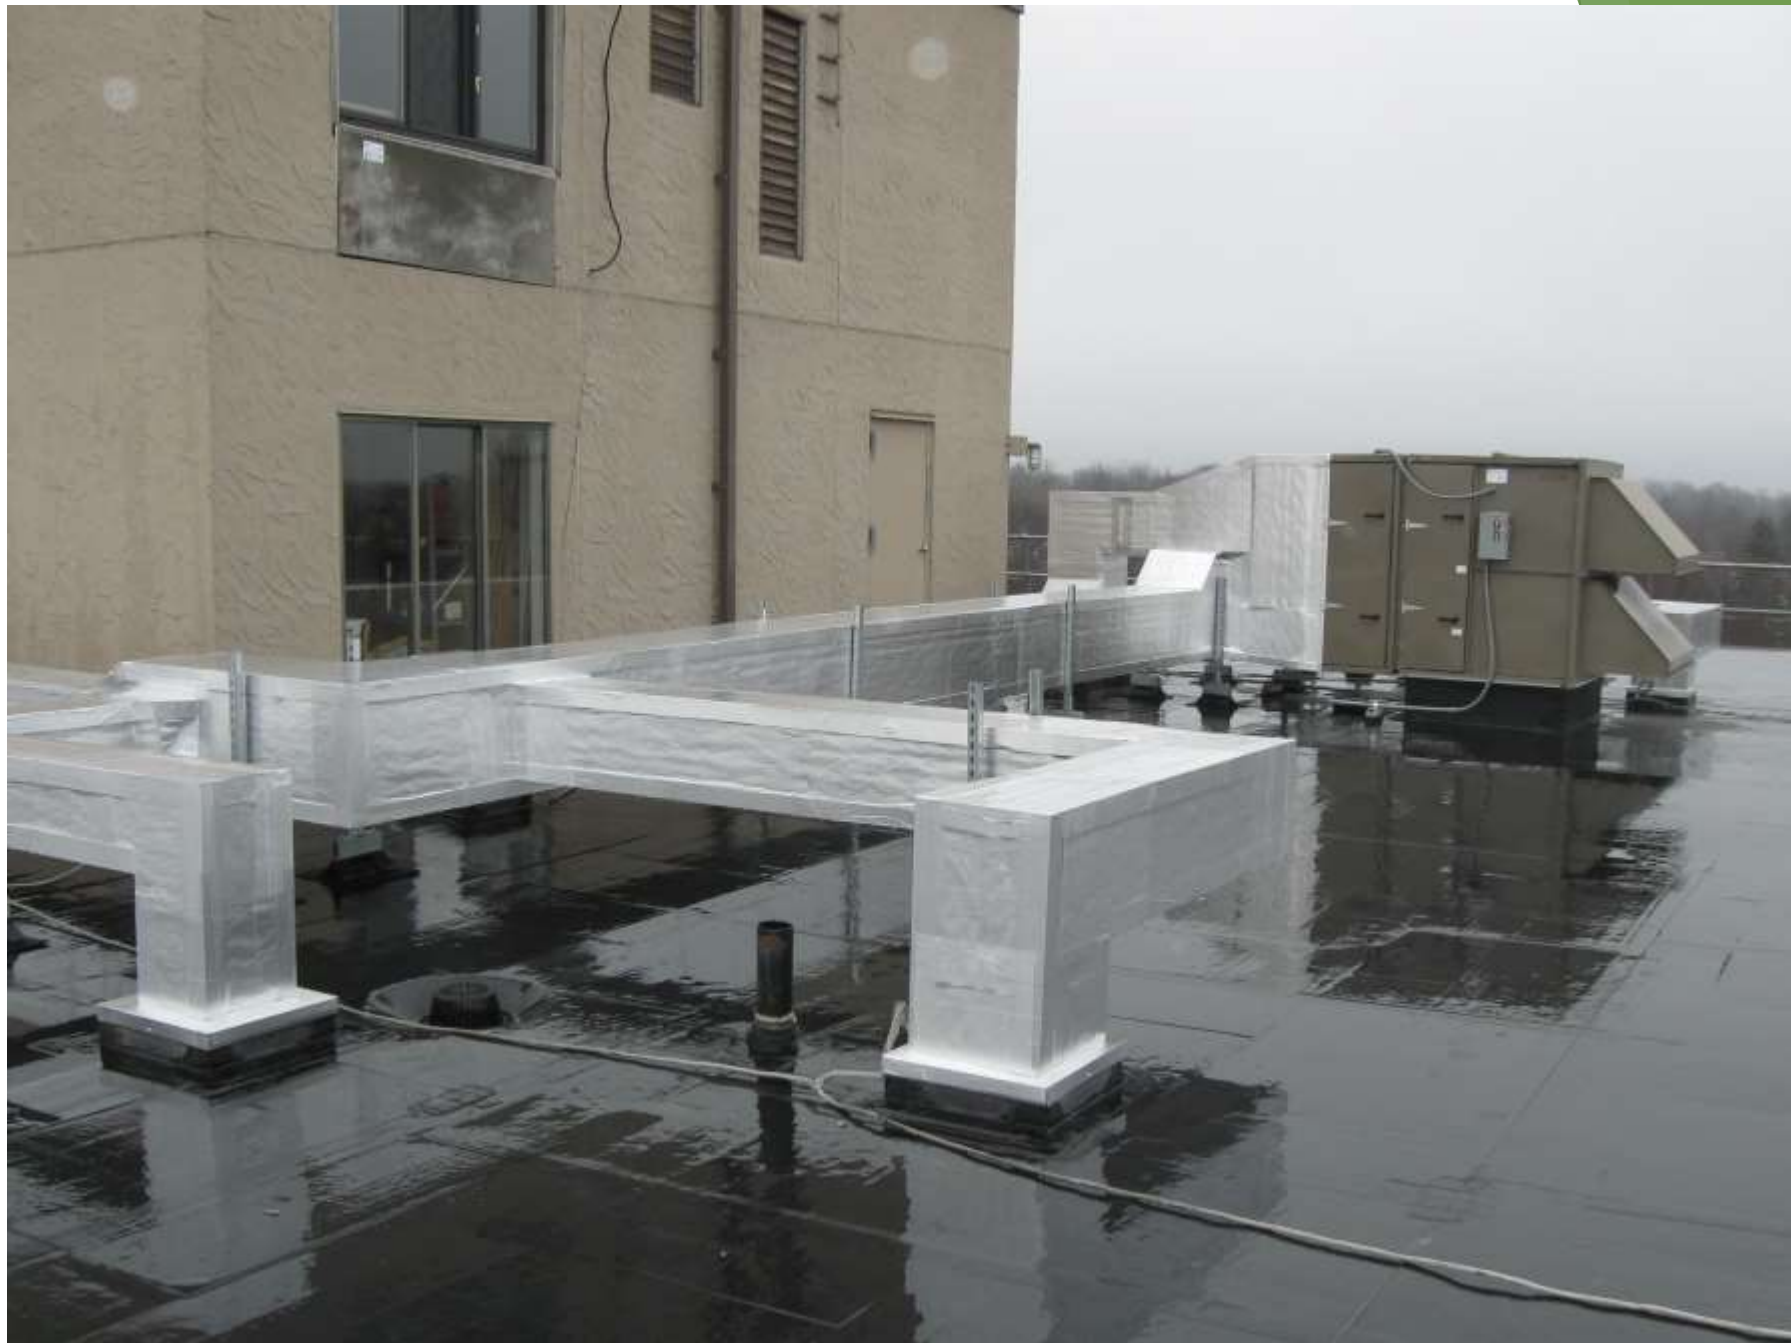
**This all electric building in Auburn added an insulated exterior skin and windows prior to My audit; we still found cost effective work by balancing the ventilation system, adding a HRV, And doing apartment electric measures.**

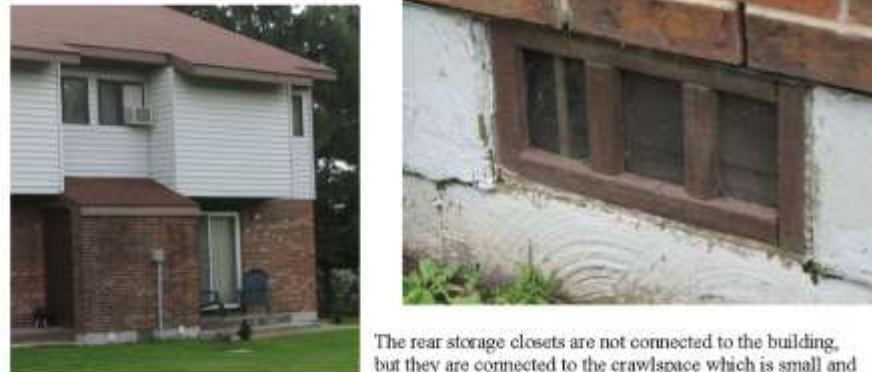
Further, the front, rear, and sliding glass doors are in poor condition, and it is cost effective to weatherstrip them. The owner wishes to replace them, and can if they pay for the majority of the cost and CPC's weatherization program invest the maximum allowed for the cost effectiveness of the weatherstripping, which would only last a few years anyway. Replacement is the better choice, but the owner must be willing to invest.

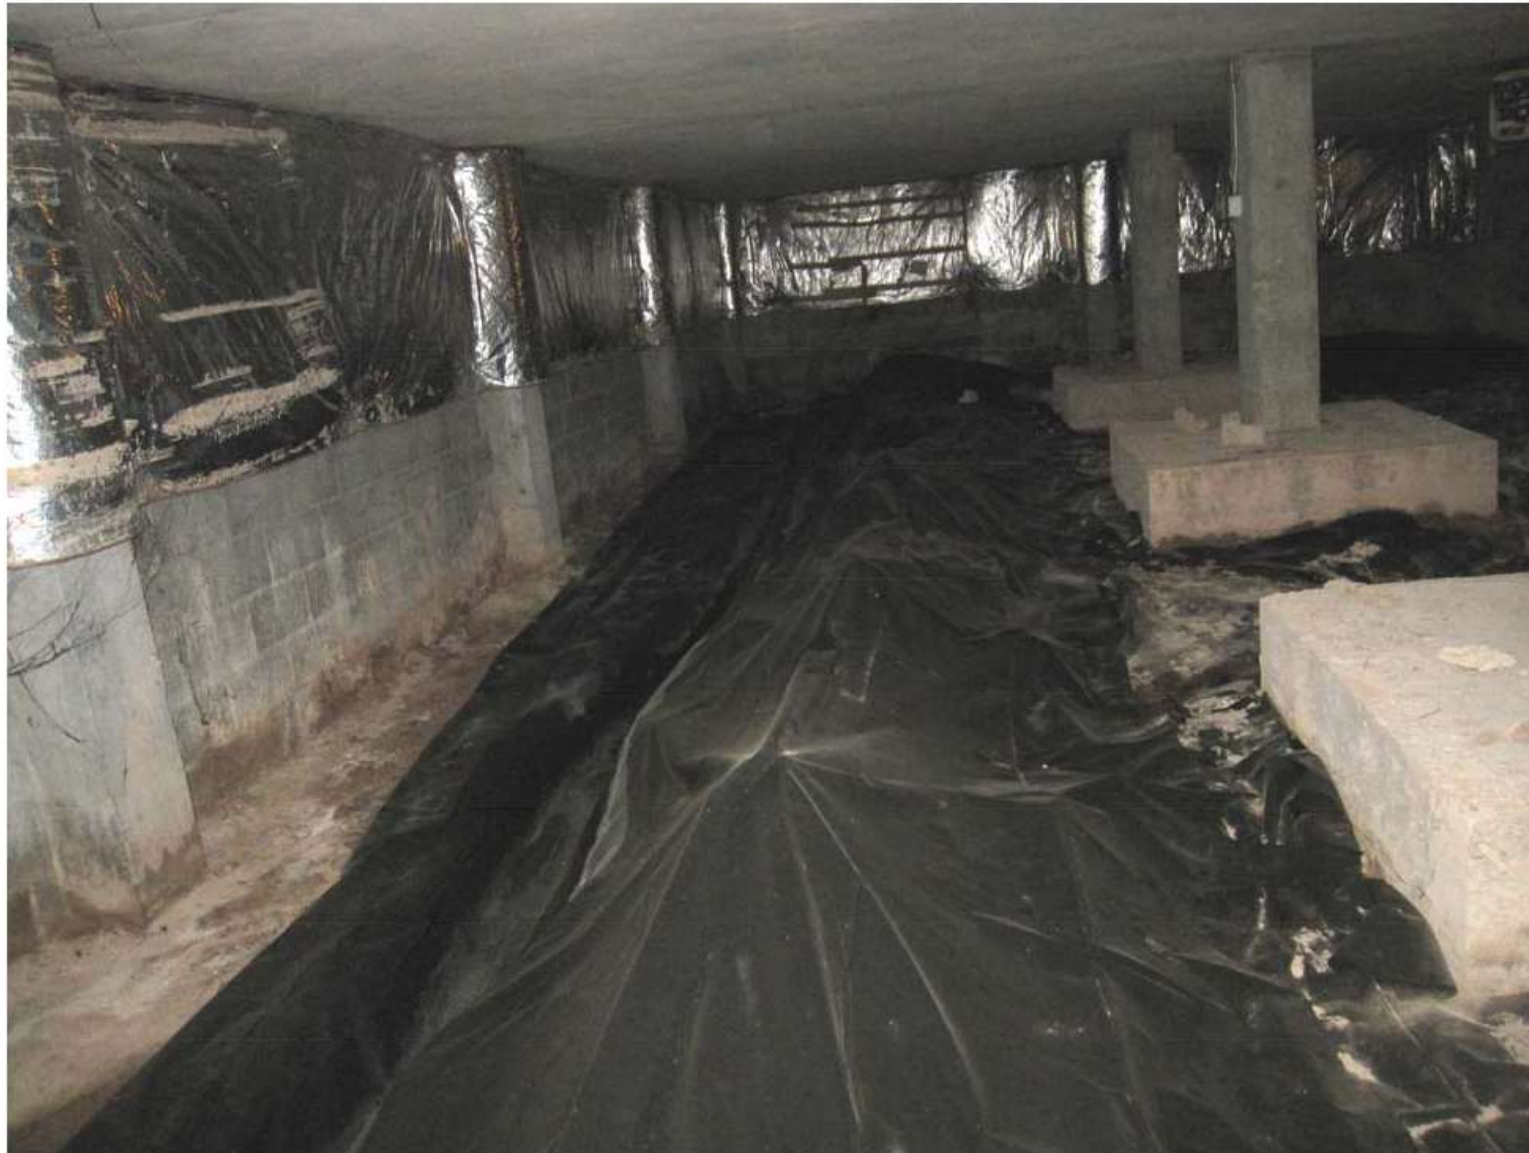
Figure 3 Typical condition at the south wall of the basement – CMU wall; top four feet covered by fiberglass roll insulation; damp footing and lower course; the earthen floor partially covered by black plastic membrane (est. 70% coverage); trench dug near the footing in an effort to direct seepage to sump crocks; concrete interior posts support the concrete floor above.

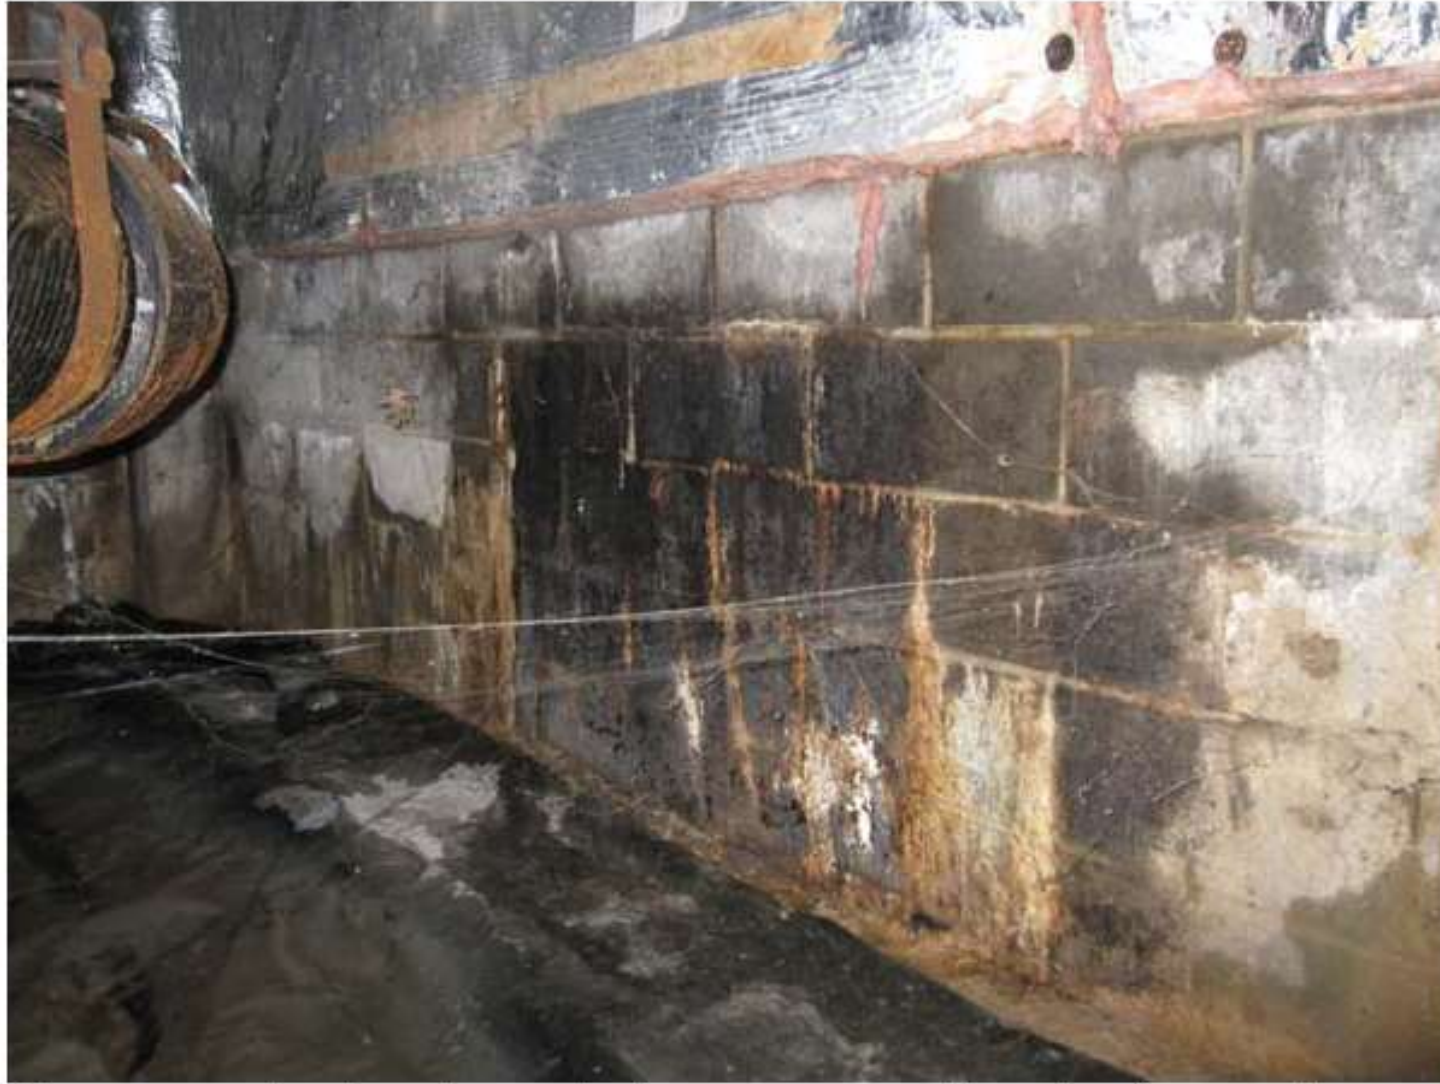
Figure 6 in the NW corner solution deposits have accumulated where rainwater runs down walls from above.

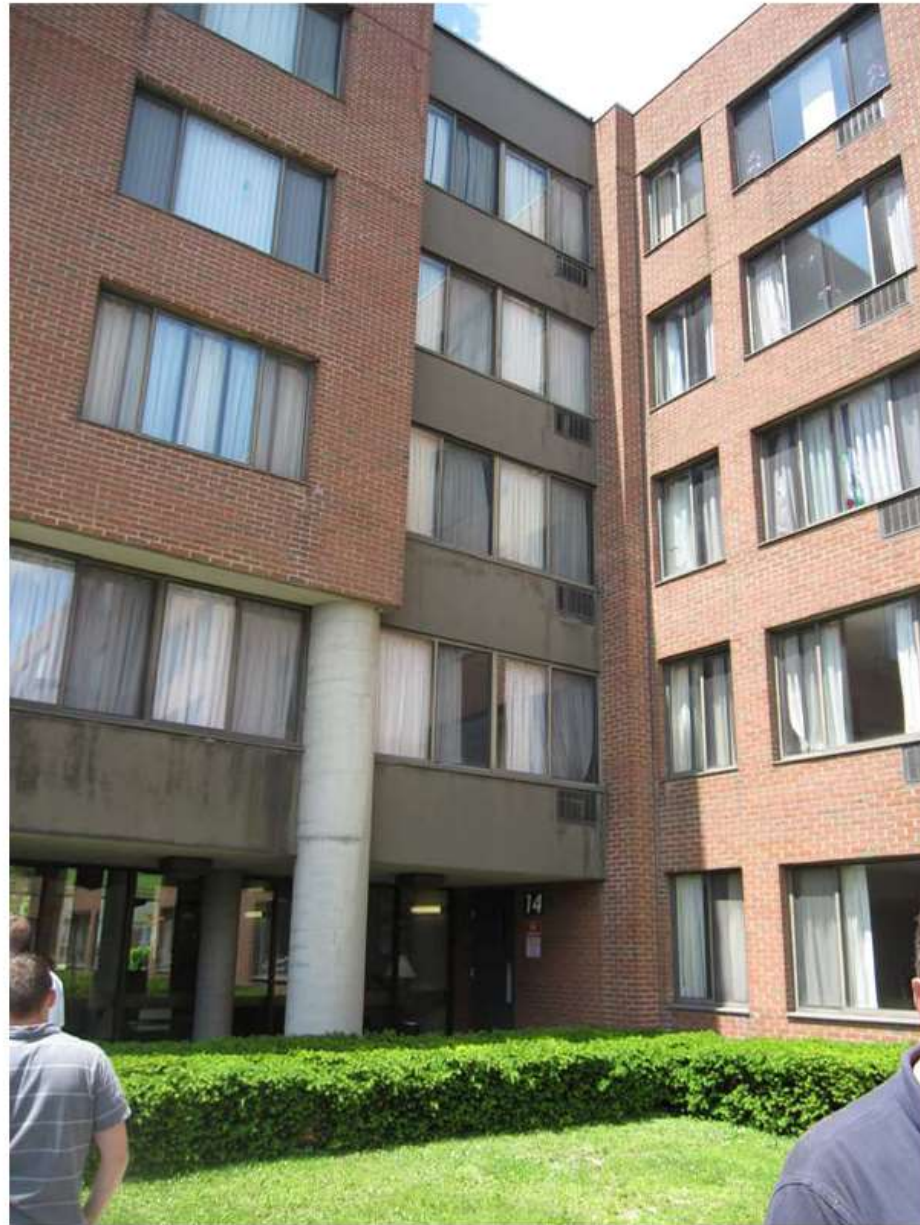
Figure 27 At the East facing entryway the detail is the same and a great deal of water enters here as well.

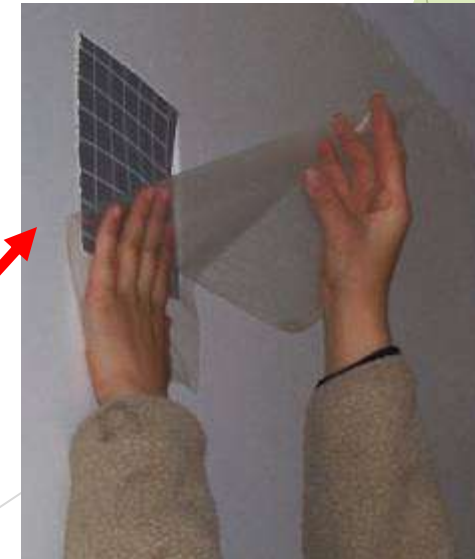
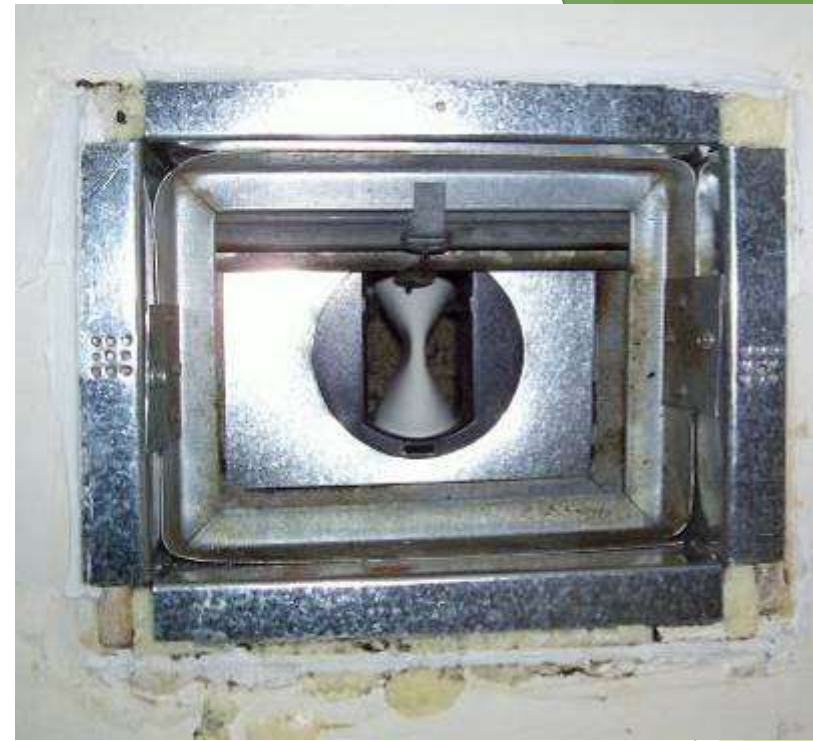
# CAR-II Constant Airflow Regulators

American Aldes
